Imaging of running-induced osseous injuries

Osseous overuse and stress-related injuries commonly occur in individuals who participate in the sport of running. While the clinical history and physical examination are important first steps in establishing the correct diagnosis, imaging often plays a vital role in confirming the diagnosis and in determining the extent of injury and prognosis for the injured athlete. This article will provide a thorough review of the numerous osseous stress injuries that occur in runners, including a summary of the high-risk stress fractures. Imaging strategies are discussed and the typical radiographic, CT, MRI and nuclear scintigraphic findings are described for each of the various stress-related injuries associated with running.

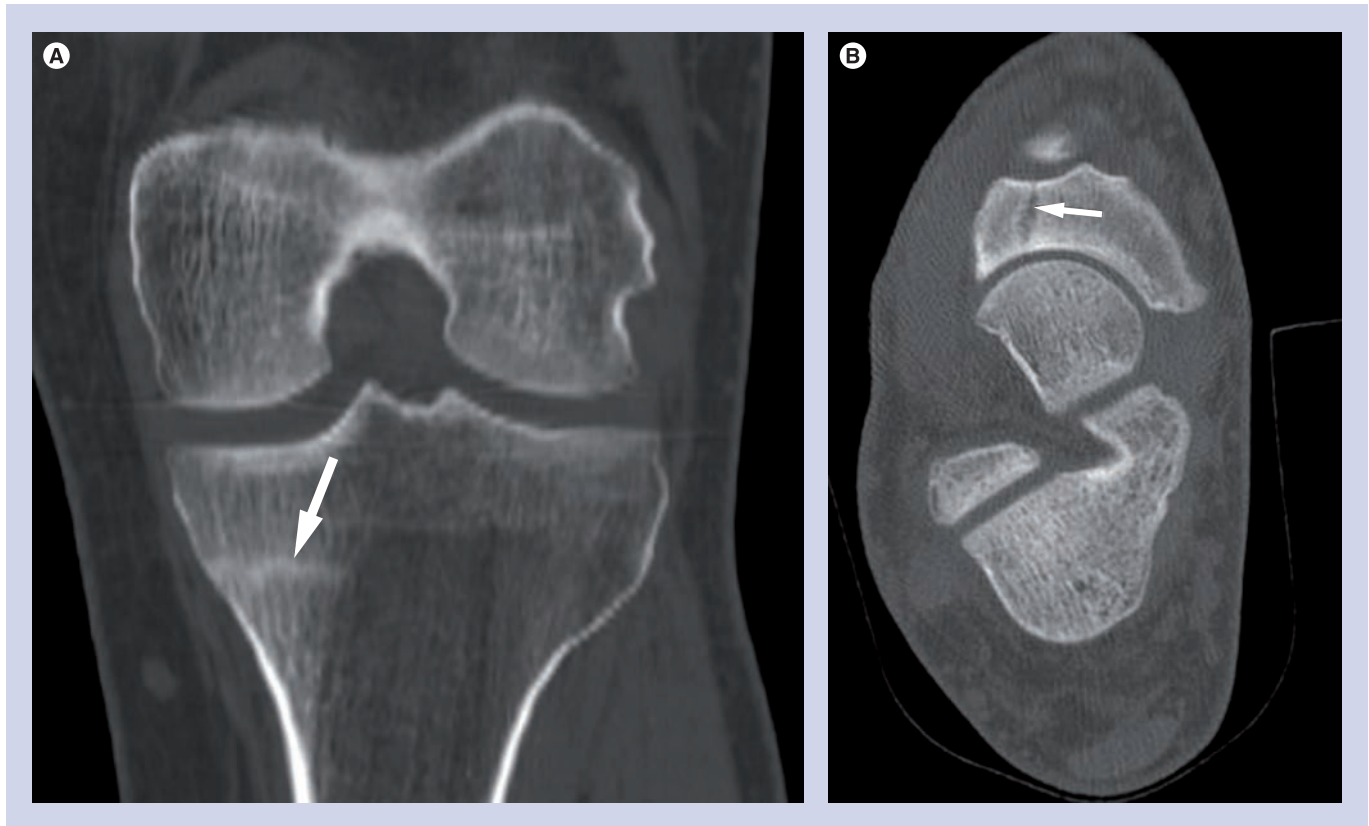
Figure 1. Stress fracture: CT imaging appearance. (A) Coronal CT reconstruction through the proximal tibia reveals a transverse linear area of sclerosis (arrow) involving the proximal medial tibial metaphysis representing a stress fracture. (B) Axial CT image through the midfoot shows a linear lucency (arrow) extending across the short axis of the tarsal navicular, indicating a stress fracture.

CT imaging only plays a limited role with regard to the evaluation of suspected osseous stress injuries of the lower extremities. However, there are a few specific instances when CT imaging can be of particular help. These include evaluation of a potential longitudinal stress fracture of the tibial shaft, evaluation of the tarsonavicular bone (FIGURE 1) or of the sesamoids of the great toe, and in detecting the presence of a nidus when attempting to differentiate an osteoid osteoma from a stress injury of the bone (SUPPLEMENTARY FIGURE 2) [9,10].

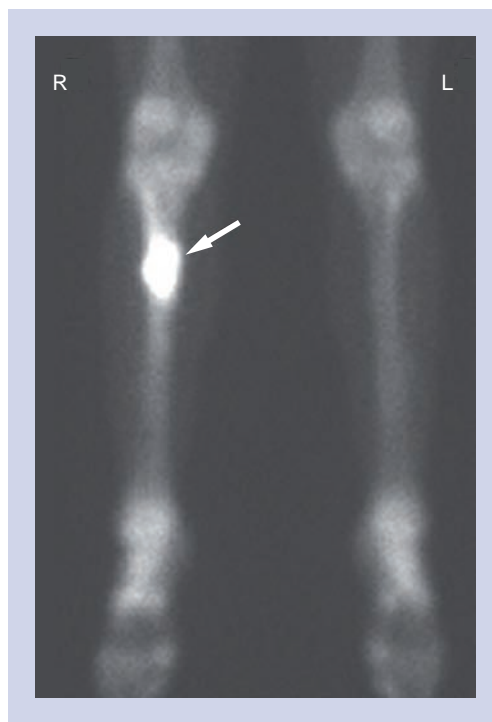
Figure 2. Stress fracture of tibia: nuclear scintigraphy. Anterior view of the lower legs shows extensive transcortical area of increased uptake indicating a grade IV lesion of the proximal tibial shaft. L: Left; R: Right.

imaging will demonstrate a detectable abnormality (FIGURE 2). Repetitive stresses placed on a bone resulting from increased activity level or a change in training regimen will result in increased turnover of bone, and the focal area of increased uptake on the bone scan corresponds to the area of increased osteoblastic activity. A normal bone scan has a high negative predictive value and in the past was thought to exclude the possibility of a stress fracture even in clinically suspected cases [15]. However, more recently, several reports of abnormal MRI examinations in the setting of a normal nuclear-medicine bone scan have demonstrated that MRI provides a higher level of sensitivity in the detection of early osseous stress changes [7,16–20]. In addition, Bryant *et al.* demonstrated that SPECT imaging can detect early stress-related changes of the femoral neck in the setting of a normal planar bone scan [18]. Zwas *et al.* developed and later refined a classification of bone scintigraphic findings, grading the extent of stress lesions from mild to severe. The grade of lesion as determined by bone scan is useful in directing therapy (TABLE 1) and in establishing an appropriate prognosis [15].

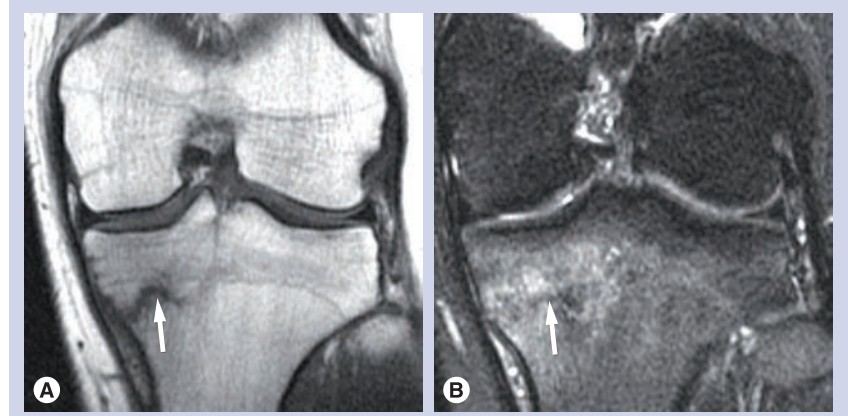
Figure 3. Stress fracture of medial tibial metaphysis: MRI appearance.

A 19-year-old runner with left knee pain. MRI – (A) coronal T₁-weighted image and (B) coronal T₂-weighted image with fat saturation – shows a transverse linear area of low signal (arrows) representing a stress fracture of the medial tibial metaphysis with surrounding marrow edema.

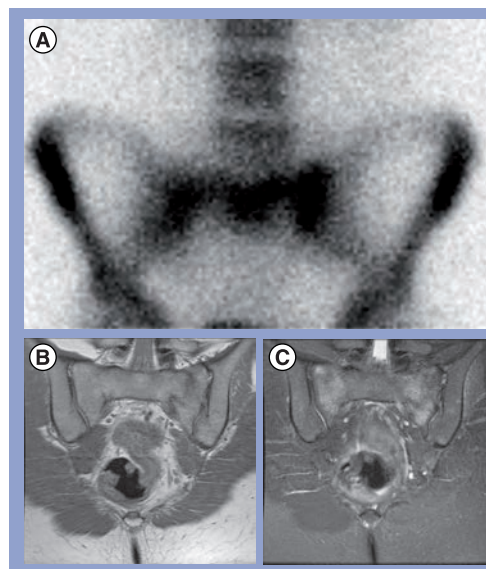
Figure 4. Bilateral sacral insufficiency fractures.

(A) Nuclear scintigraphy shows increased uptake within the sacral ala bilaterally. (B) Coronal T₁-weighted image shows vertical linear-appearing low-signal abnormality with increased T₂ signal in the same distribution seen on (C) the coronal T₂-weighted image. This pattern is diagnostic of bilateral sacral insufficiency fractures.

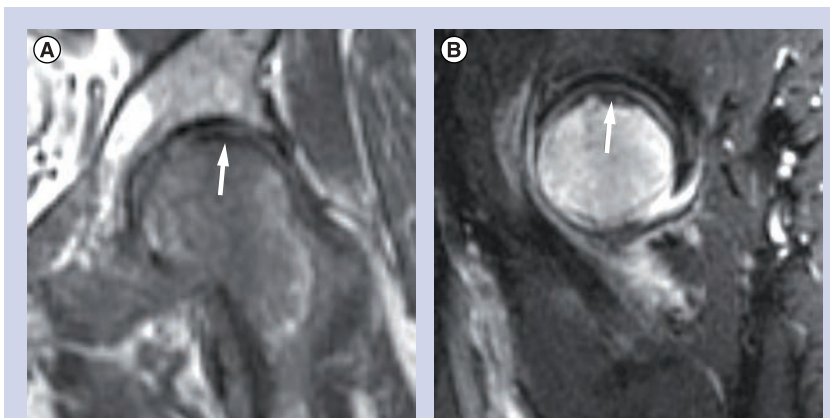
Figure 5. Subchondral fatigue-type stress fracture of the femoral head. (A) Coronal T₁- and (B) sagittal T₂-weighted images demonstrate a low-signal intensity line (arrows) in the subchondral region of the femoral head with diffuse marrow edema located throughout the femoral head and neck region. This was noted in a young long-distance runner with hip pain. The patient went on to heal without cortical collapse of the femoral head following appropriate therapy.

Radiographs are typically normal at the time of presentation. MRI demonstrates an ill-defined low-signal intensity line paralleling the subchondral plate of the femoral head with diffuse marrow edema noted throughout the femoral head (FIGURE 5). Insufficiency-type subchondral fractures often progress to cortical collapse, leading to secondary osteoarthritis while collapse of the femoral head in fatigue-type subchondral fractures appears to be uncommon [24]. The increased incidence of collapse in insufficiency-type fractures may be associated with inferior quality bone in this subset of elderly patients when compared with the young athletic population. Conservative treatment with nonweight bearing usually leads to resolution of MRI findings and symptoms in the young patient. In patients with hip pain and diffuse subchondral marrow edema on MRI, a thorough search should be made

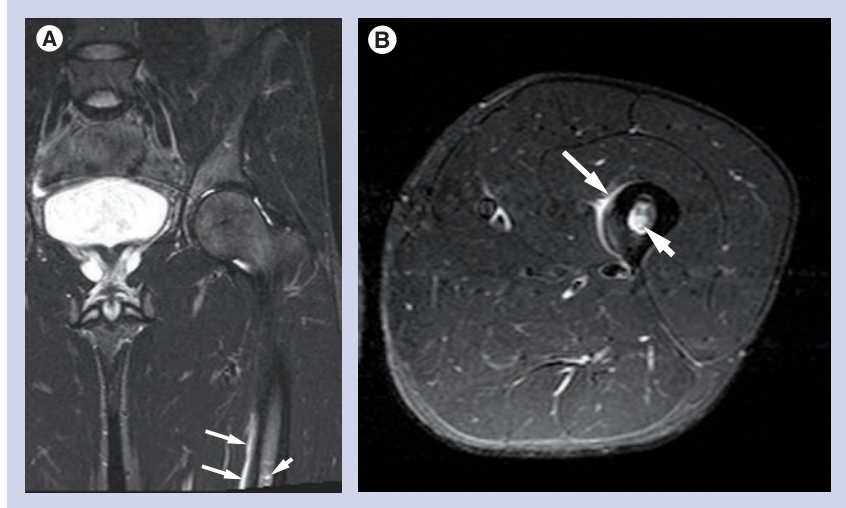
Figure 6. Adductor insertion avulsion syndrome thigh splints. (A) Coronal and **(B)** axial T₂-weighted images through the proximal thigh demonstrate a long segment of periostitis (long arrows) along the medial aspect of the proximal femur with intracortical and intramedullary edema (short arrows).

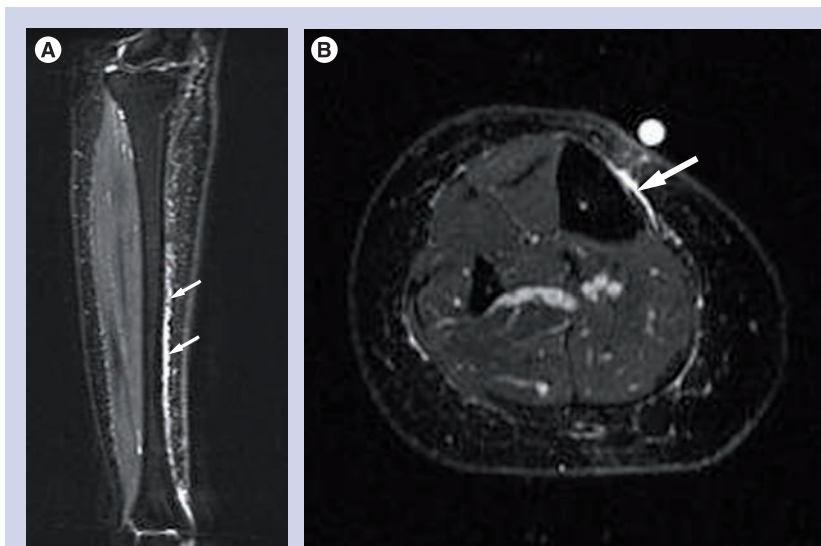
Figure 7. Medial tibial stress syndrome (shin splints). (A) Sagittal and (B) axial T_2 -weighted images through the calf demonstrate subperiosteal edema (arrows) located along the medial aspect of the distal two-thirds of the tibia. The underlying cortex and medullary space is normal with no edema or evidence of a stress fracture.

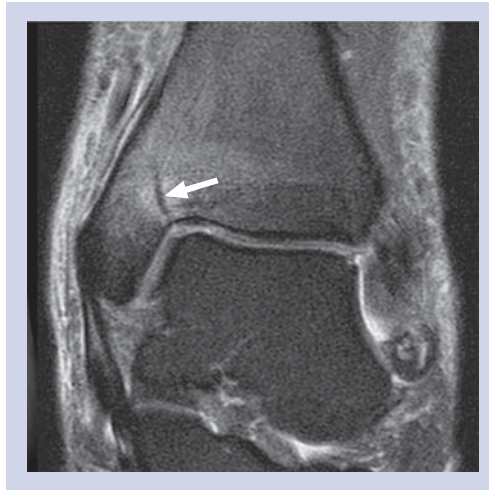
Figure 8. Stress fracture of the medial malleolus of the tibia in a 29-year-old male runner. Coronal T₂-weighted image through the ankle shows an incomplete nondisplaced fracture of the medial malleolus of the distal tibia. The fracture extends from the medial tibial plafond into the medial malleolus (arrow) with surrounding marrow edema. Courtesy of James Linklater (Castlereagh Sports Medicine Imaging, Crows Nest, Australia).

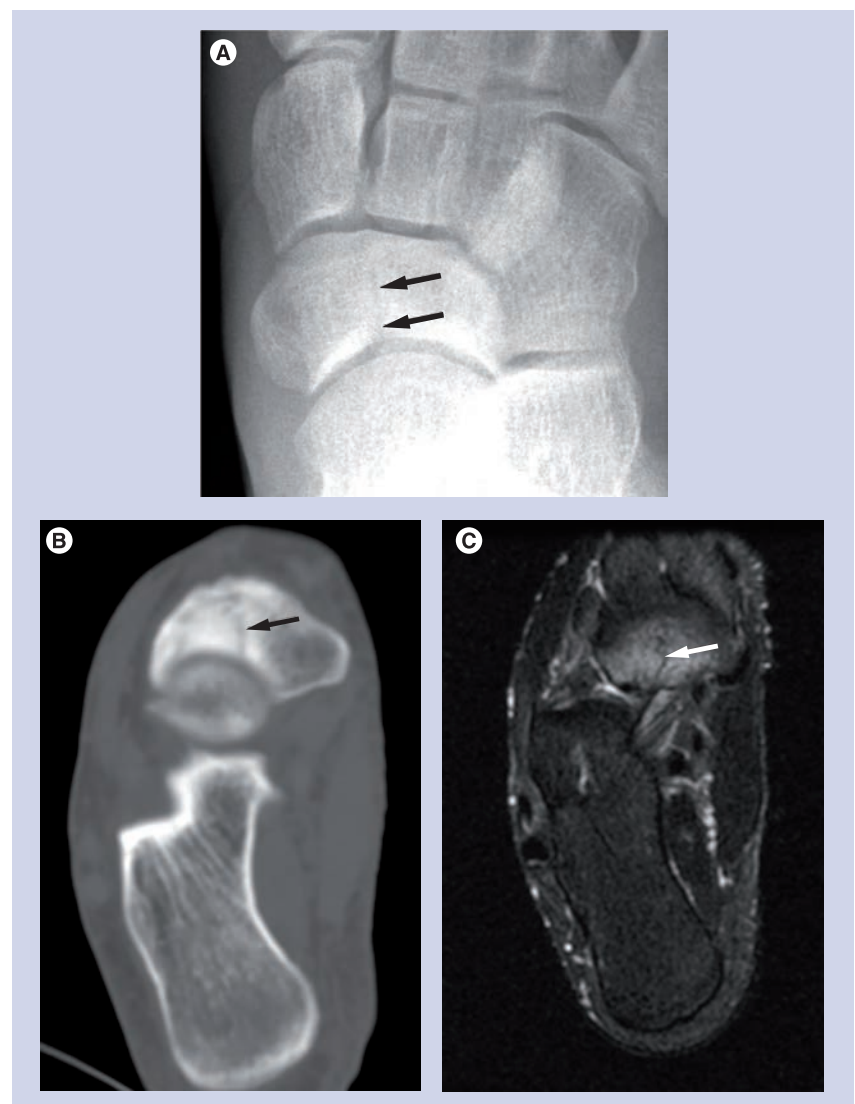
Figure 9. Stress fracture of the tarsal navicular. (A) Anteroposterior radiograph shows an incomplete linear lucency extending to the proximal articular surface of the tarsal navicular bone, indicating an advanced stress fracture (arrows). **(B)** CT image through the long axis of the midfoot shows a linear lucency (arrow) extending to the proximal articular surface with adjacent sclerosis. **(C)** Axial T₂-weighted image shows the stress fracture (arrow) with adjacent marrow edema.

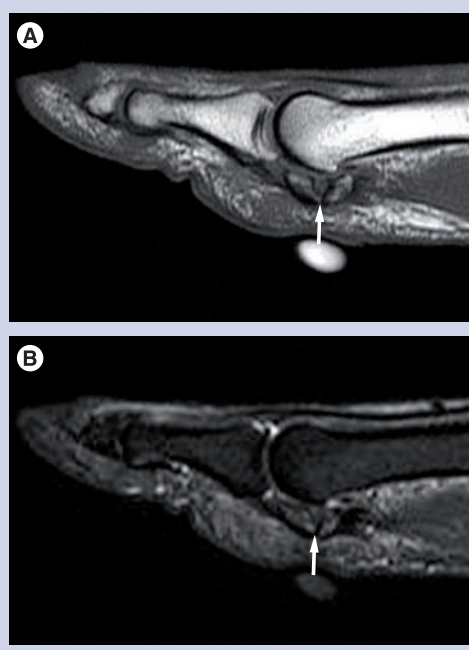
Figure 10. Stress fracture tibial sesamoid. (A) Sagittal T₁- and (B) T₂-weighted images through the forefoot demonstrates a vertical stress fracture (arrows) through the tibial sesamoid.
