No cut, just close: Trans catheter device closure of mitral paravalvular leak

Case Report

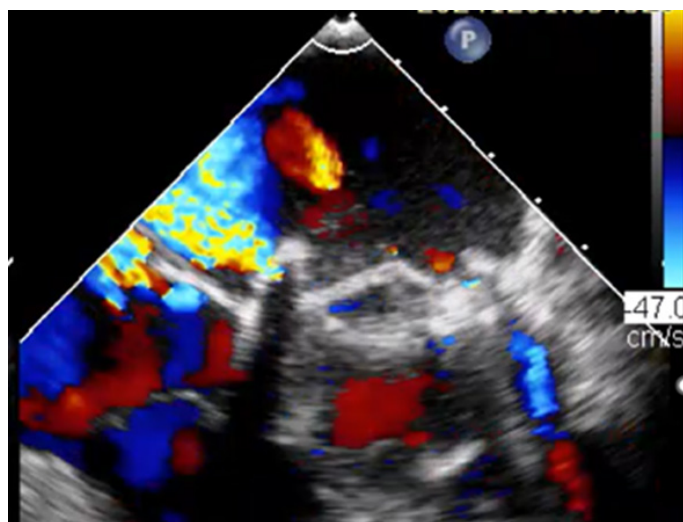
Figure 1: TEE showing moderate to severe paravalvular leak.

onset Dyspnea on Exertion (DOE). Laboratory findings revealed elevated NT-pro BNP levels, suggestive of heart failure. 2D echocardiography and TEE was done which showed a moderate to severe paravalvular leak, a dilated Left Atrium (LA), a color jet flow area >50%, a Vena Contracta (VC) of 0.7 cm, a regurgitant fraction (RF) of 55%, and a Regurgitant Volume (R Vol) of 60 ml (Figure 1). Considering the patient's recent open-heart surgery and the feasibility of a transcatheter approach, he was planned for transcatheter device closure of the paravalvular leak.

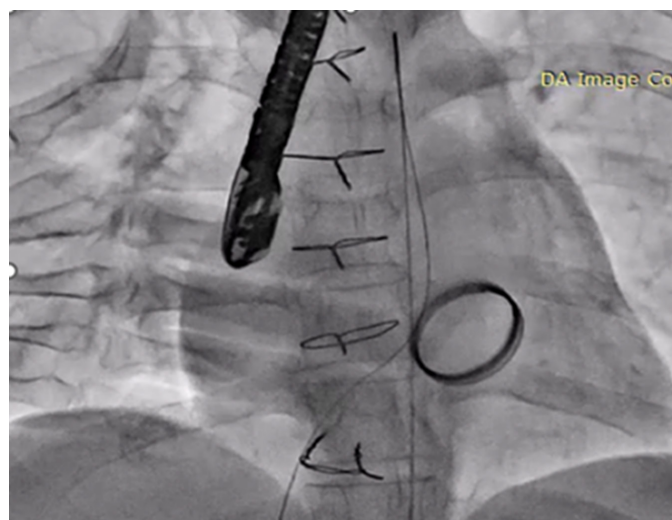
Figure 2: Crossing of the paravalvular leak with 0.032" Terumo wire.

The procedure started by taking access through Right Femoral Artery (RFA), Right Femoral Vein (RFV), and Left Femoral Artery (LFA). A pigtail catheter was placed in the Left Ventricular (LV) cavity. A Transseptal (TSP) needle was used to puncture the septum, which was confirmed with a Left Atrial (LA) contrast injection. A JR catheter was advanced across the Paravalvular Leak (PVL) over a 0.032" Terumo wire into the LV cavity under 3D TEE guidance (Figure 2).

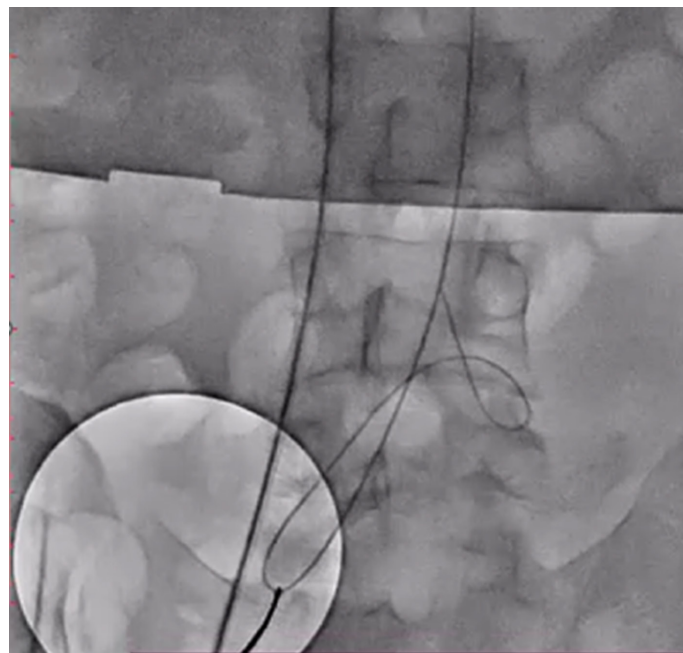
Figure 3: Snaring of double length terrumo wire from the device.

The 0.032" Terumo wire was then exchanged for a double-length Terumo wire, which was subsequently snared from the aorta using a 6F snare (Figure 3). The JR catheter was exchanged for an MPA catheter, which was positioned in the descending aorta. The Terumo wire was then exchanged for an Amplatzer Super Stiff wire (Figure 4).

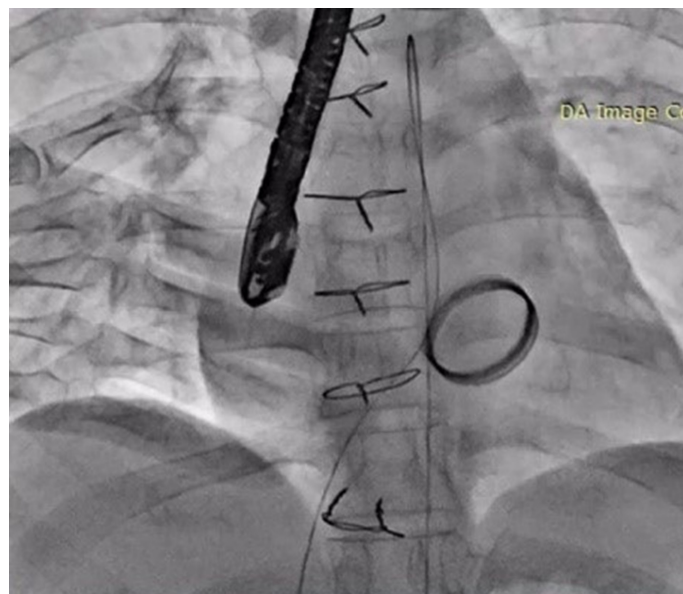
Figure 4: Exchanging double length terrumo wire with the amplatzer superstiff wire.

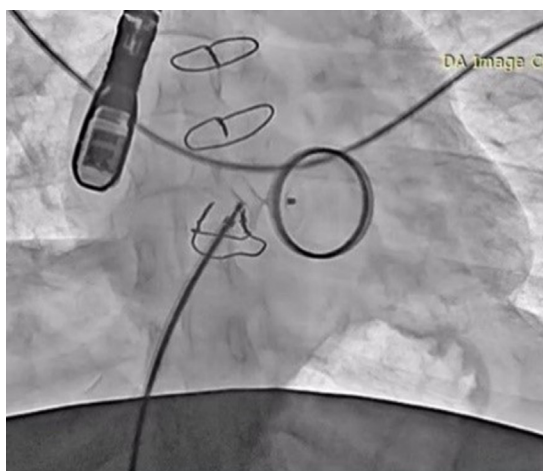
Figure 5: Positioning of Konar MF VSD Occluder device (12/10) across the defect.

A Lifetech Konar MF VSD Occluder device (12/10) was deployed across the defect, and its position was confirmed by 2D echocardiography, TEE, and 3D TEE (Figure 5). After confirming the correct positioning of the device and the absence of any residual leak, the device was released (Figure 6).

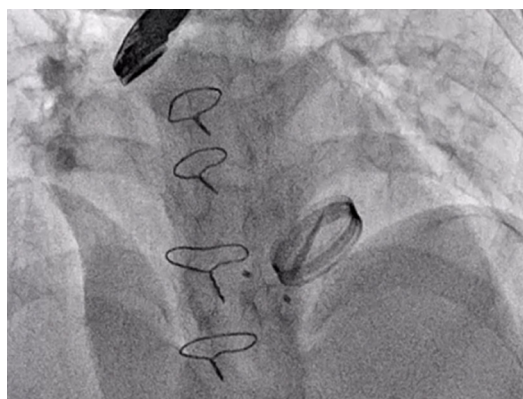
Figure 6: Device released after confirming the position under TEE guidance.

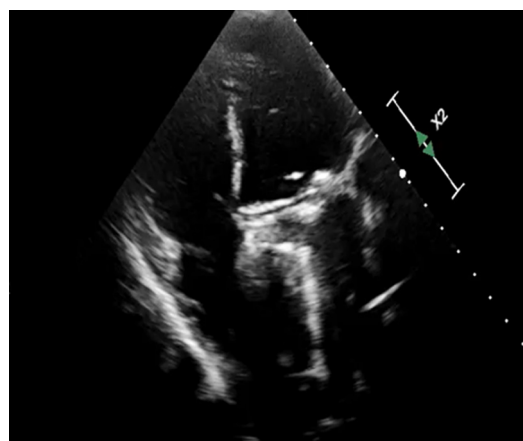
Figure 7: Post operative transthoracic echo suggestive of device in place over the defect.

Post-procedure, the patient was monitored in the Intensive Coronary Care Unit (ICCU) and was started on Vitamin K Antagonist (VKA) anticoagulation after bridging with heparin. The patient was discharged after stabilization. At 1-month follow-up, the patient remained stable without any complaints. 2D echocardiography and 3D TEE confirmed that the device was well-positioned, with no residual paravalvular leak (Figures 7 and Figure 8).

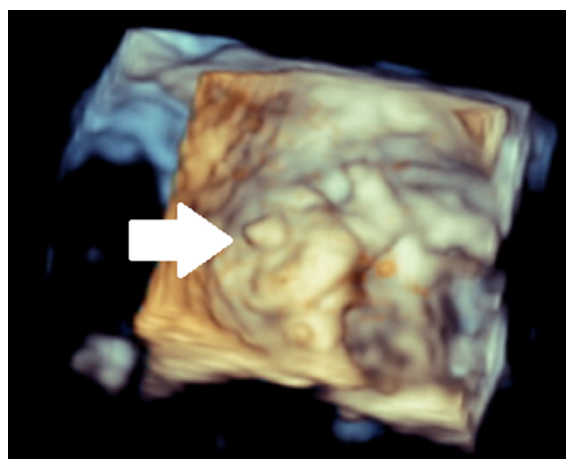
Figure 8: Image of 3D TEE showing MV with device (pointed with arrow).
